LEATHERWOOD CREEK NO. 6

# PHASE I INSPECTION REPORT

## NATIONAL DAM SAFETY PROGRAM

JULY 1981

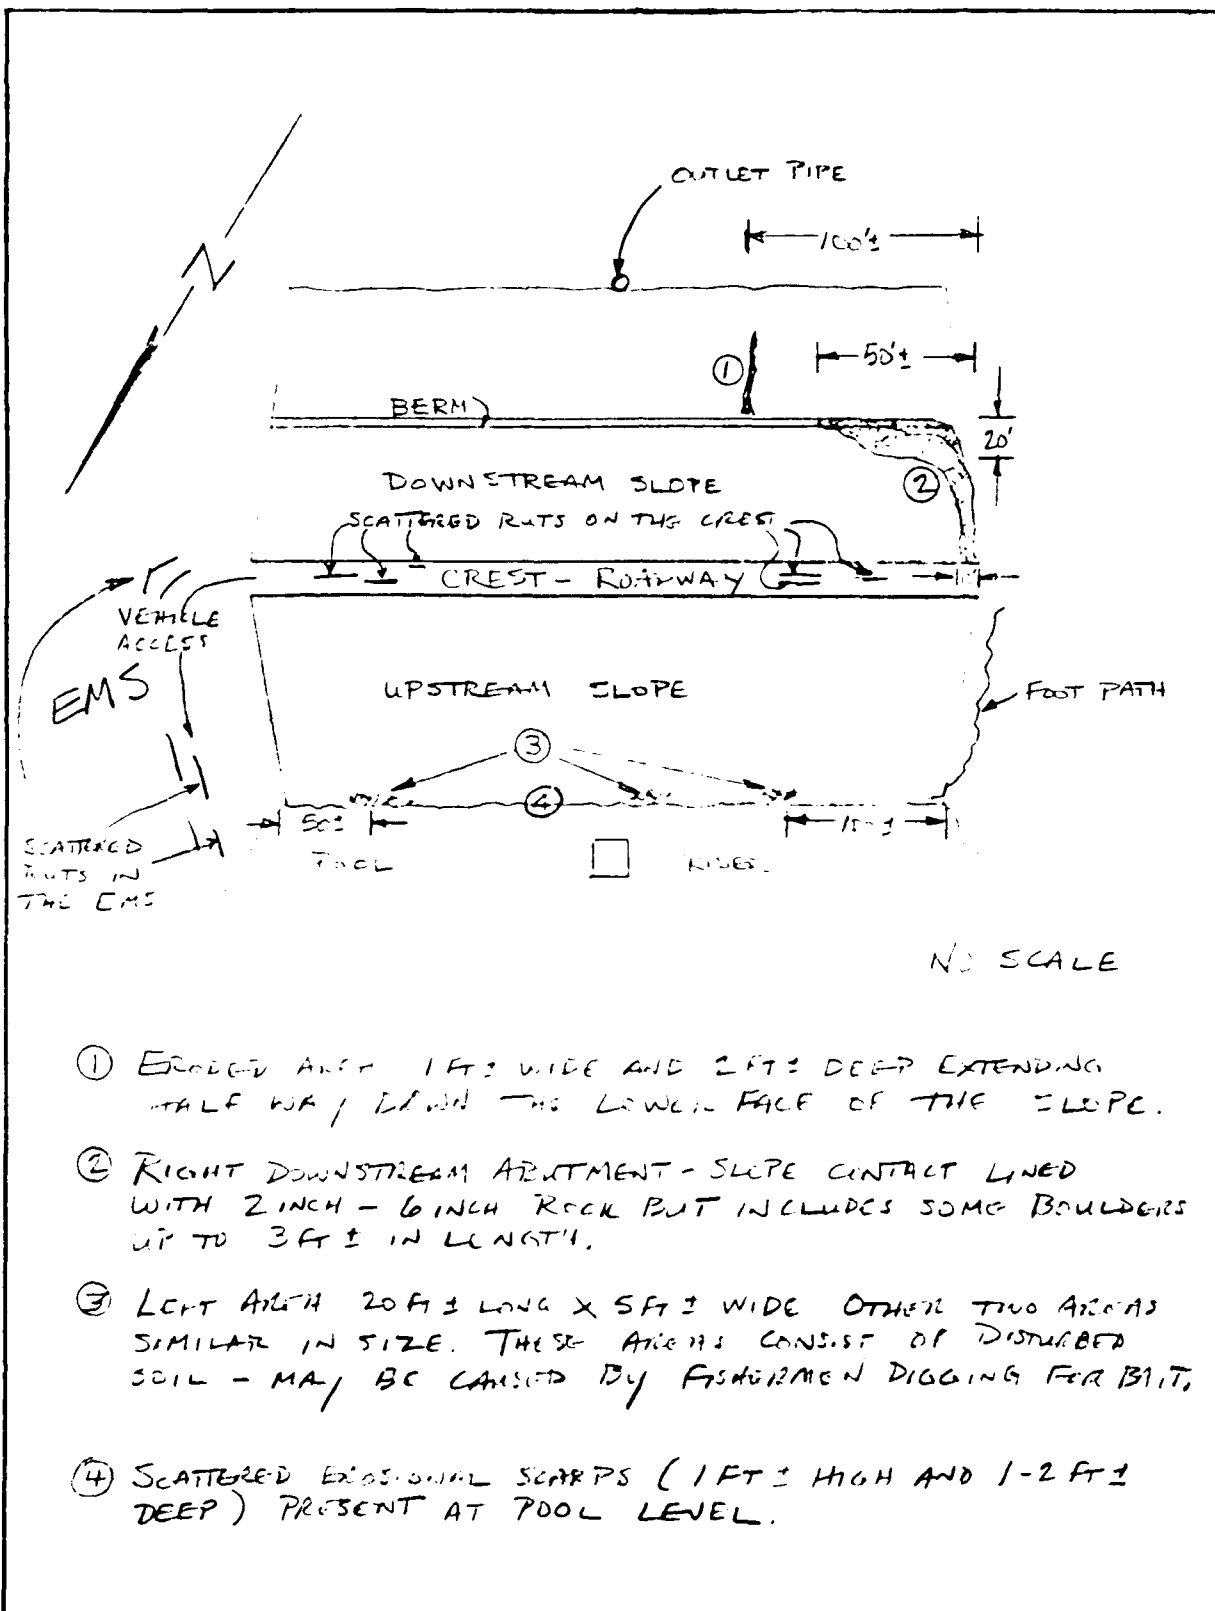
- ① ERODED AREA 1 FT± WIDE AND 2 FT± DEEP EXTENDING HALF WAY DOWN THE LOWER FACE OF THE SLOPE.
- ② RIGHT DOWNSTREAM ADJUTMENT - SLOPE CONTACT LINED WITH 2 INCH - 6 INCH ROCK BUT INCLUDES SOME BOULDERS UP TO 3 FT± IN LENGTH.
- ③ LEFT AREA 20 FT± LONG X 5 FT± WIDE OTHER TWO AREAS SIMILAR IN SIZE. THESE AREAS CONSIST OF DISTURBED SOIL - MAY BE CAUSED BY FISHERMEN DIGGING FOR BAIT.
- ④ SCATTERED EROSIONAL SCARPS (1 FT± HIGH AND 1-2 FT± DEEP) PRESENT AT POOL LEVEL.
